UNITED STATES
DEPARTMENT OF THE INTERIOR
BUREAU OF MINES

Memorandum

Subject: Report on investigation of minor coal outburst (bump) Moss No. 2 mine, Clinchfield Coal Company, Clinchfield, Virginia

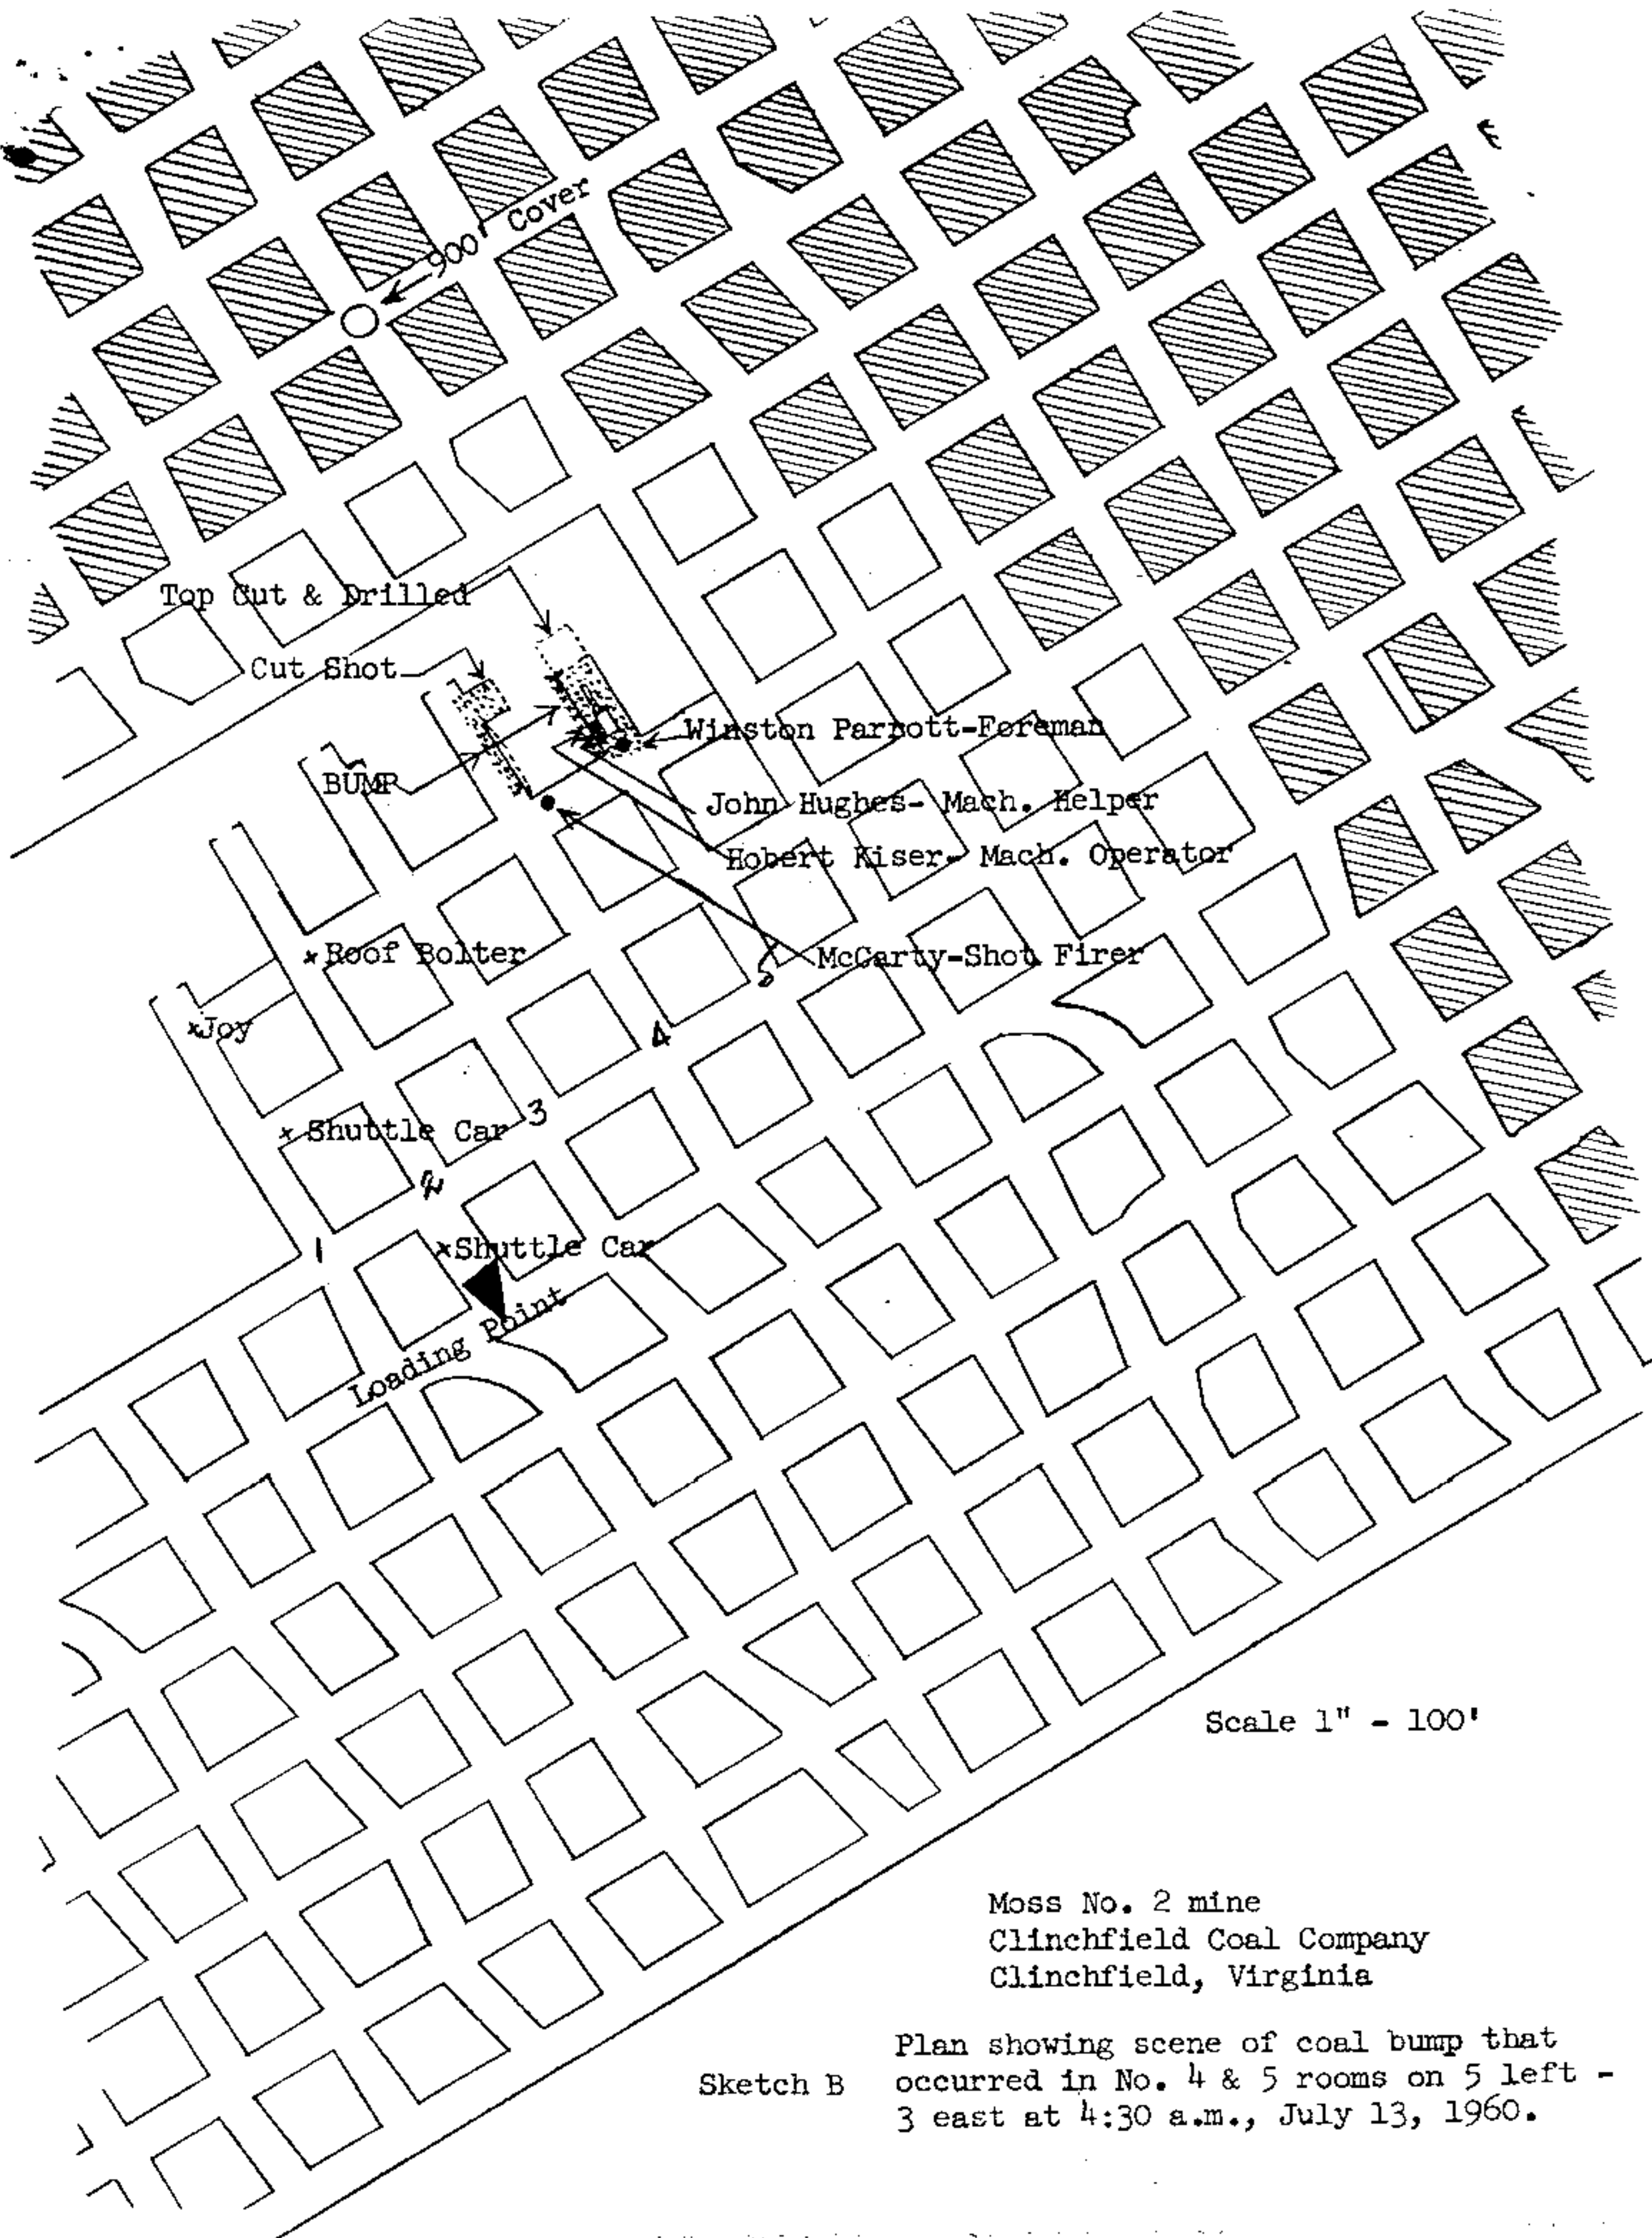
the roof from being affected adversely during the period the section would remain idle. But unfortunately, 4 of the 5 rooms being developed had advanced to within an abutment zone, or probably to the most highly stressed portion of the room-panel block when mining was discontinued. Extent of extraction and development in the 5 left 3 east section, when mining was discontinued in March 1960, is shown in Sketch A, attached hereto. It is well to point out that Nos. 2, 3, 4, and 5 rooms had been driven nearly abreast, as indicated in Sketch A, within the abutment zone directly toward the adjacent 4 left mined-out area.

Effects of the bump were confined to Nos. 4 and 5 rooms, as indicated in Sketch B, with the greatest forces being expanded on the left side of the pillar next to the face of No. 5 room and to a lesser degree in the face of No. 5 room. The opposite pillar (right side) in No. 5 room was not affected. Approximately 10 tons of coal were thrown from the right side

of the pillar next to the face in No. 4 room. The shock from the ultimate failure of the left side of the pillar in No. 5 room was sufficiently intense to expel coal from the entire length of the pillar to a depth of 2-1/2 feet at the center of the roadway. A cavity 4 to 6 inches in height, 6 feet in length and extending about 6 feet over the coal pillar resulted from the comparatively violent explosion of the coal. Insofar as could be determined, the roof and floor were not affected. A dense cloud of dust was thrown into suspension and, reportedly, methane gas was liberated which was soon swept away after line brattices and the check curtain in No. 5 room were repaired. About 8 tons of coal was loaded before the cutting machine could be trammed out of No. 5 room.
